# TECHNICAL SERVICE BULLETIN

73-A-8

# Austin MG

FUEL TANK SLOW FILLING

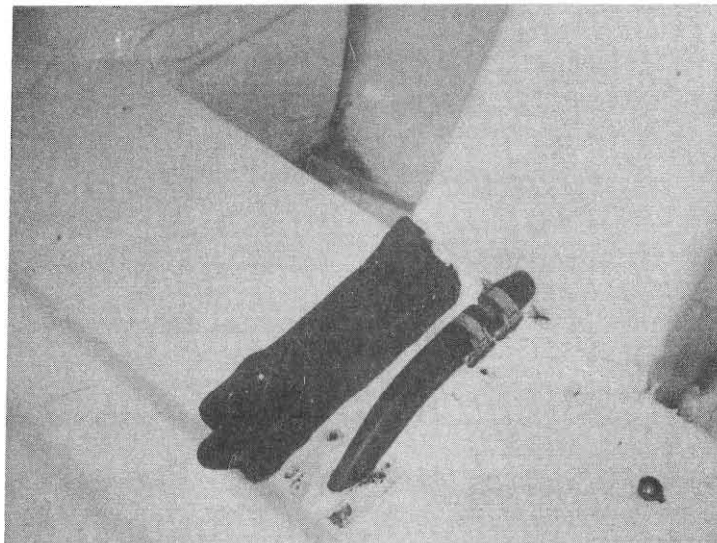
If this condition is encountered, it may be caused by a partially trapped or kinked breather tube.

This can be rectified by removing the trunk mat and removing the four screws securing the protector plate (see photograph) which will expose the breather tube. Check that the tube is free of kinks and that it has not been trapped by the protector plate.

NOTE: It may be necessary to shorten the length of the venting tube to insure a bend-free routing of the tube.
