TECHNICAL SERVICE BULLETIN

NO. 73/D/6

Difficult Selection and
Disengagement of Reverse Gear

Austin Marina

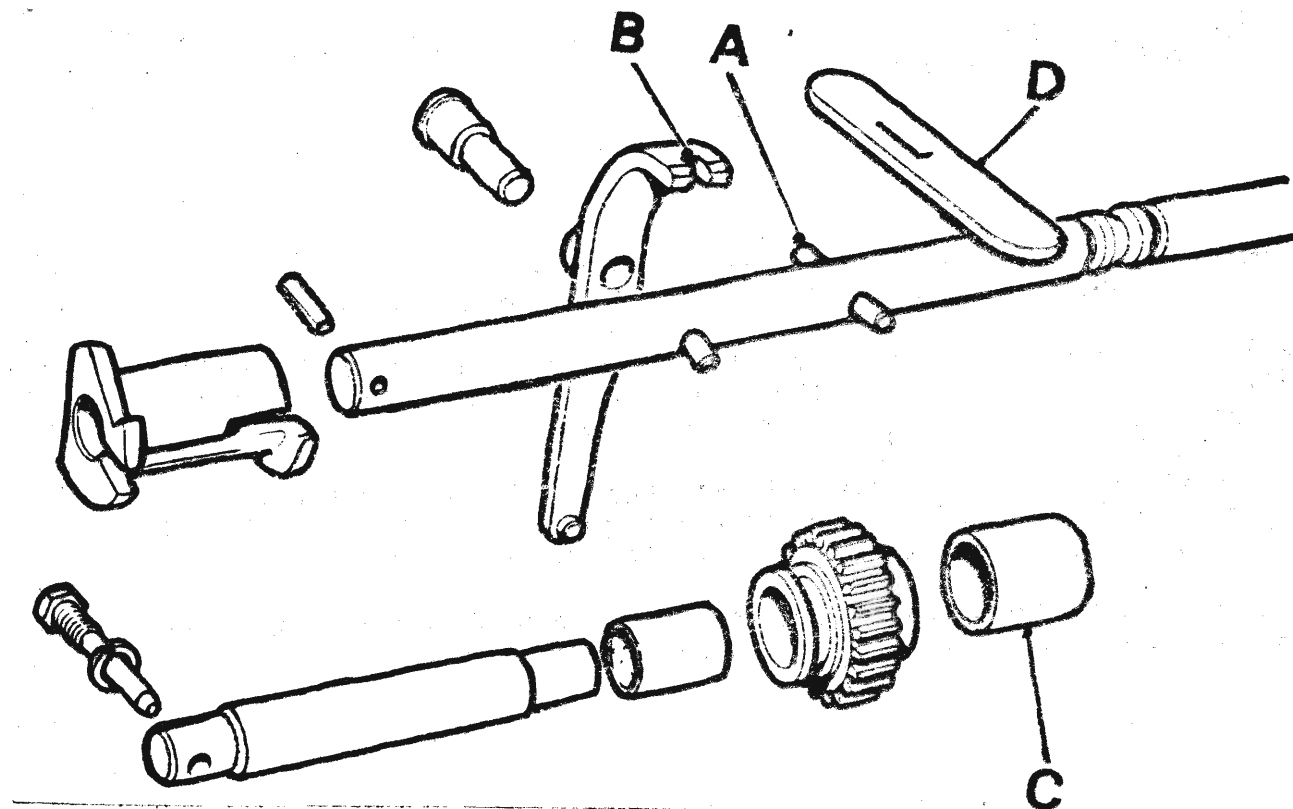
Remove the gearbox top cover and, with the selector shaft in the neutral detent, check the position of the reverse selector pin 'A' in relation to the slot 'B' in the reverse operating lever.

If the pin and slot are found to be misaligned, this may be due to an incorrectly dimensioned reverse idler gear spacer 'C', Part No. 22G 1435, which should be reduced in length to 1.070 ins. (271.8 mm).

An incorrectly dimensioned spacer will also create difficulty in locating the interlock spool plate 'D' in its correct position.
