TECHNICAL SERVICE BULLETIN

NO. 74-C-1

WATER LEAKS

AUSTIN MARINA

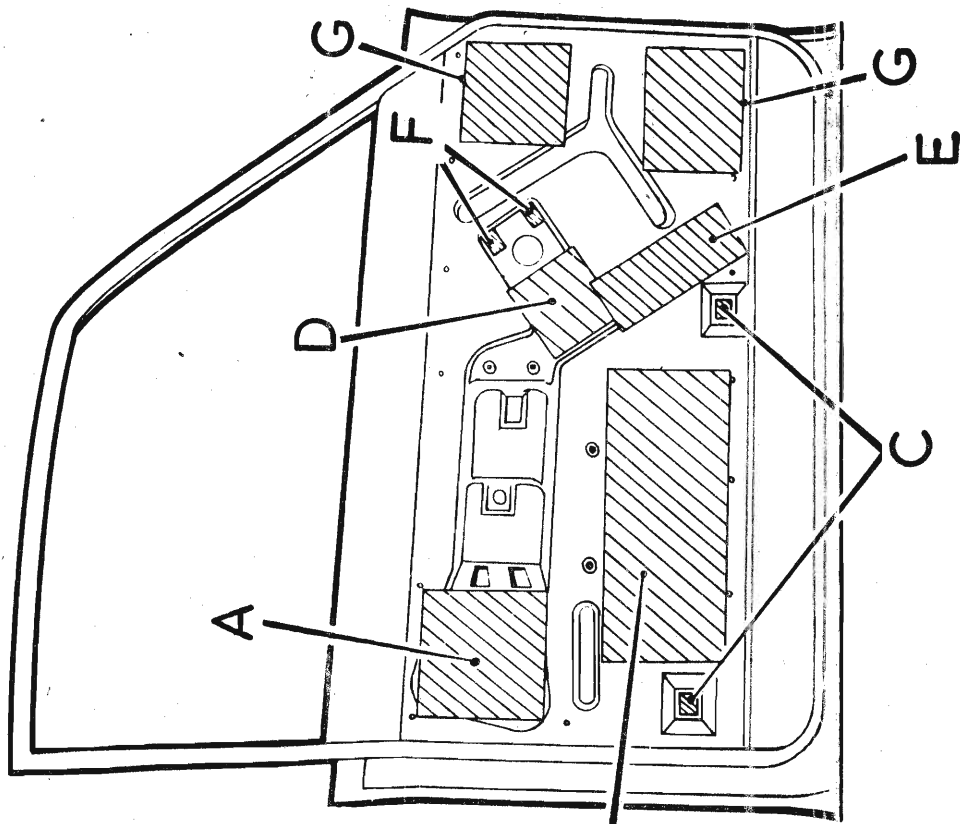
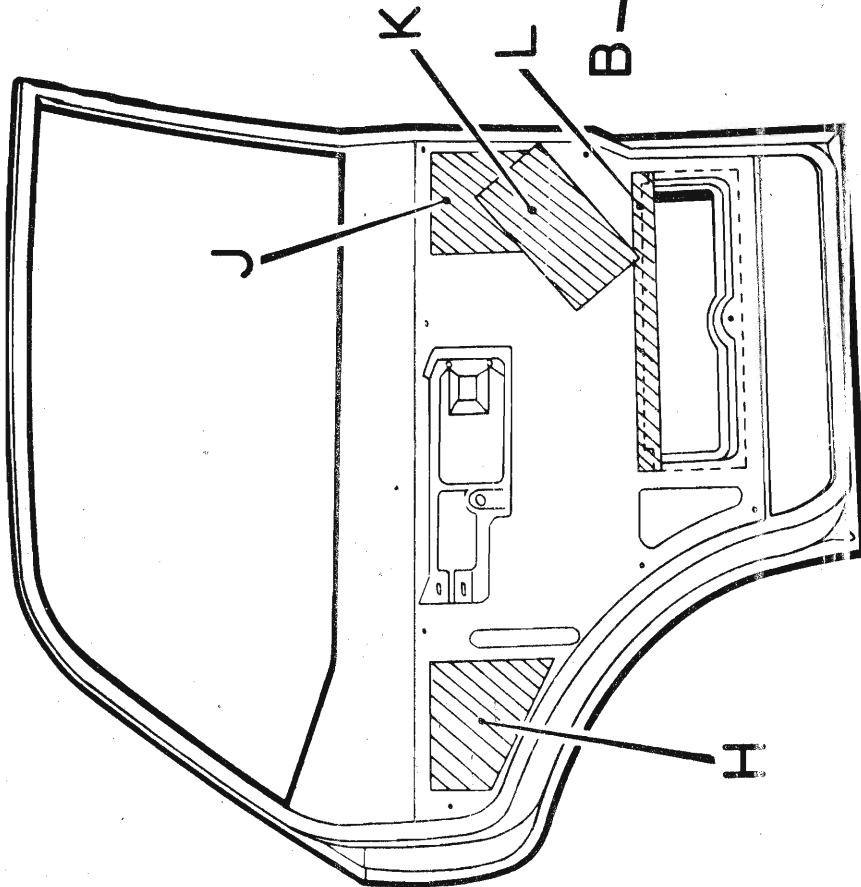
If water is found in the front footwell of the Austin Marina, it may be due to the tape patches coming adrift from the door panel apertures (see diagram). We would remind you that the windscreen should also be checked for leaks, in accordance with Technical Service Bulletin #73-C-2.

Suitable waterproof tape, 4-1/2 in. wide, which is not affected by extreme temperature changes is generally available from local jobbers and is best suited for this application.

Size of patches required:

- A = 6" x 6"
- B = 13-1/2" x 6"
- C = 2" x 1-1/2"
- D = 3-1/2" x 3"
- E = 7" x 3"
- F = 1" x 1"
- G = 7" x 5-1/2"
- H = 6" x 5-1/2"
- J = 7" x 5-1/2"
- K = 7-1/2" x 5"
- L = 14" x 2"
