# TECHNICAL SERVICE BULLETIN

NO. 74-D-3

PREVENTION OF  
DRIVE PLATE FAILURE

AUSTIN MARINA

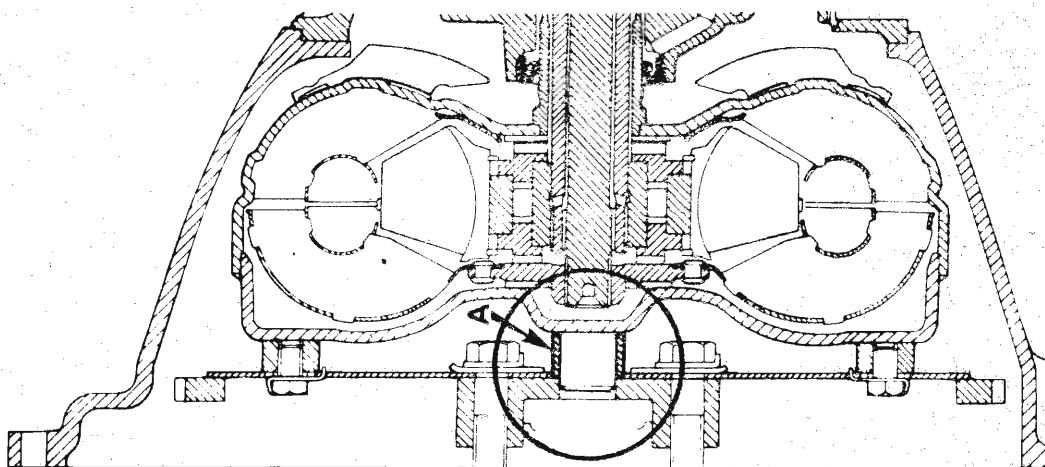
When transmissions are being dismantled for any reason which necessitates the removal of the converter, care must be taken when reassembling to insure that the converter abutment ring "A" (Part No. 22H 1391), as shown in the illustration below, is refitted.

Failure to observe this requirement will result in subsequent drive plate failure due to the complete loss of drive plate preload.

NOTE: The illustration in the Repair Operation Manual (Page 44.00.06) is incorrect and will be amended in due course.
