Austin MG

February, 1975

DIRECTION INDICATOR/WINDSCREEN WIPER
SWITCHES

MARINA

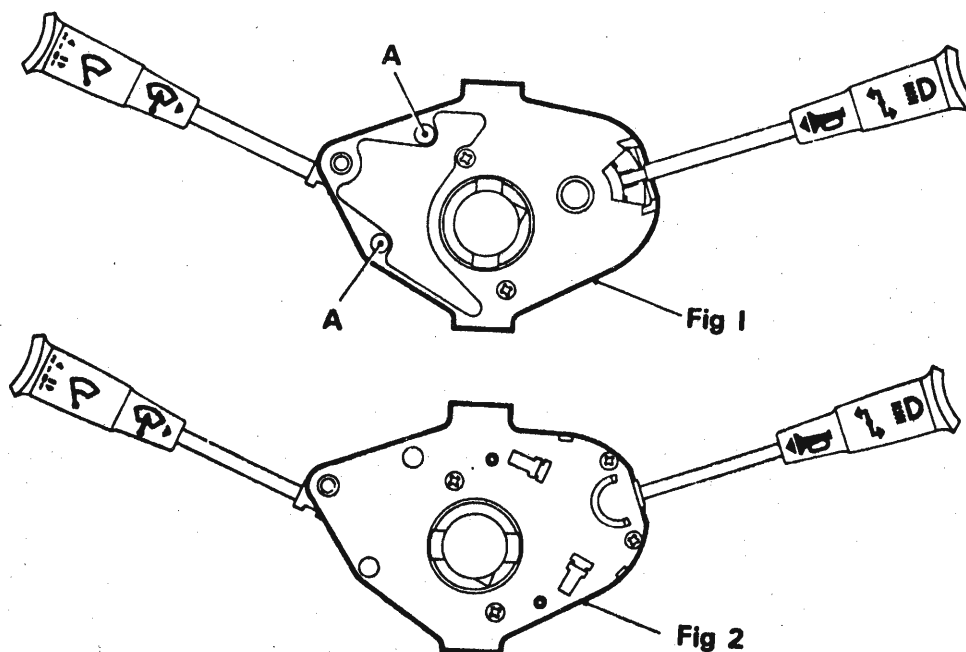
Whilst the individual wiper or direction indicator switches of the original assembly, Fig. 1, are serviced separately, this is not the case as far as the alternative switch, Fig. 2, is concerned.

Should it be necessary to replace a switch of the latter category, this can only be done by obtaining the two individual switches included in the assembly shown in Fig. 1.

Please note the switch, Fig. 1, is dismantled by removing the two rivets 'A' and reassembled using the two screws supplied with the replacement switches.

1973 - Direction Indicator - Lucas Part No. 39742
" - Windscreen Wiper - Lucas Part No. 39743

1974 - Direction Indicator - Lucas Part No. 39818
" - Windscreen Wiper - Lucas Part No. 39819
