TECHNICAL SERVICE BULLETIN

75-A-6

August, 1975

MIDGET 1500 CC OVERHEATING

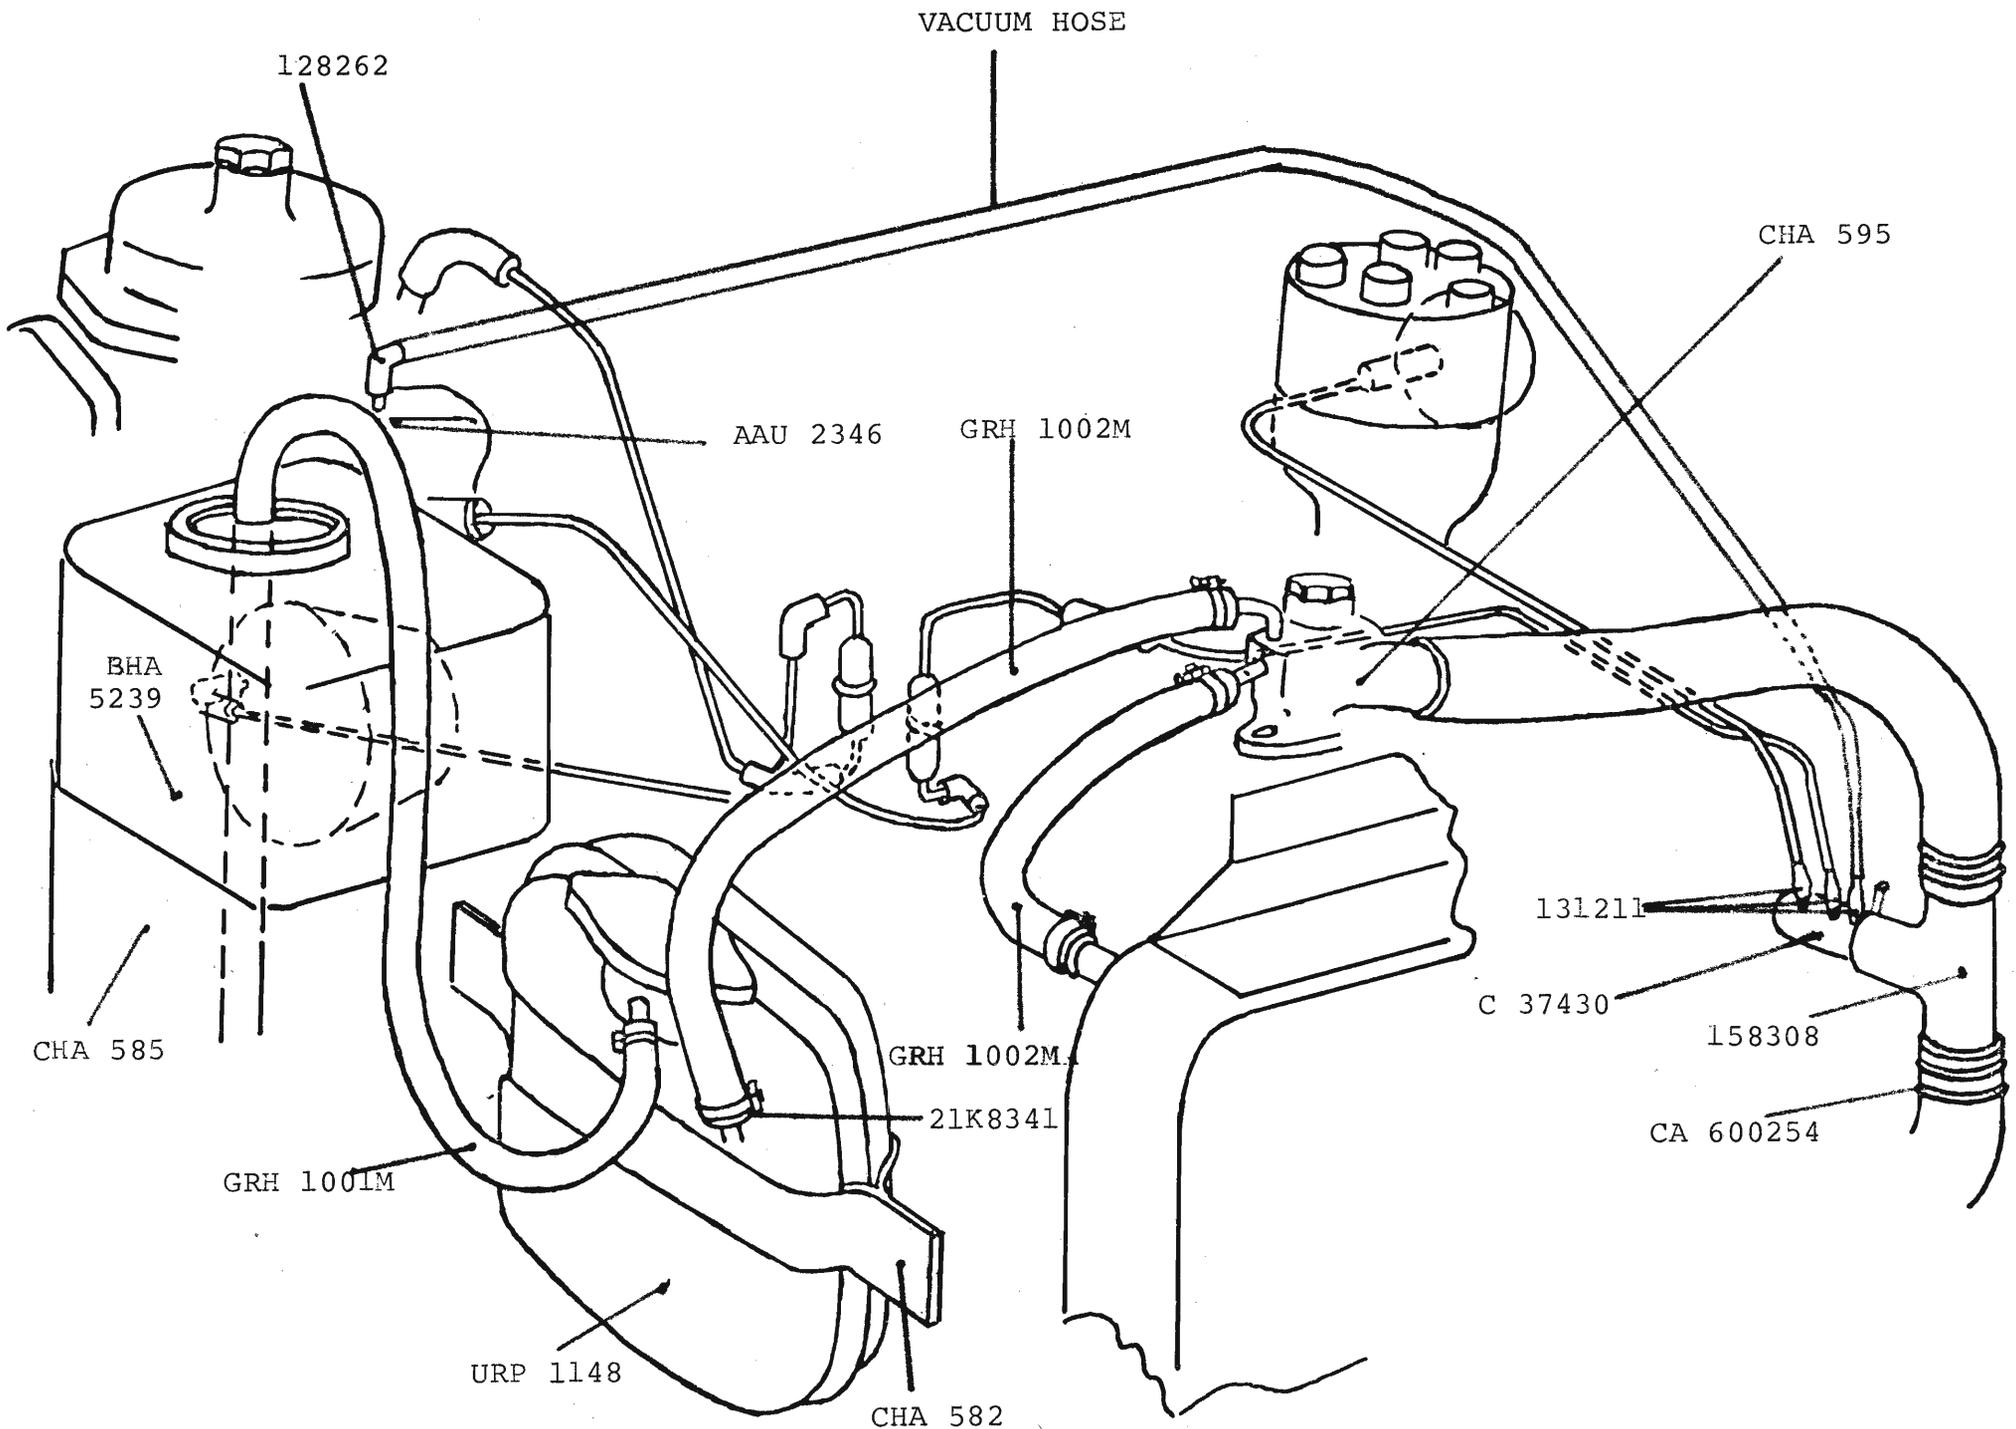
Where instance of severe overheating occurs on 1975 MG Midgets, the following modifications should be carried out.

1. Remove and discard the front number plate bracket and plinth assembly. Relocate and mount the front number plate to the center of the bumper, using self-tapping screws.
2. Reposition both horn assemblies by simply bending the mounting bracket upwards and through 90°.
3. Install thermo-vac switch, Part No. C-37430 with 'T' sleeve adaptor, Part No. 158308 in the top radiator hose as shown.

NOTE:- (Remove approximately 1 1/4" from the existing hose to accomodate the 'T' sleeve.)

4. Remove the decell valve from the carburettor and replace with externally vented valve, Part No. AAU-2346.
5. Remove and discard the existing expansion tank and replace with metal type, Part No. URP-1148, using the existing bolts and spacers and new brackets supplied, Part No. CHA-582.

NOTE:- The pressure cap supplied with the metal tank has a double seal, and therefore is not interchangeable with the original cap which should be discarded.

6. Install bracket, Part No. CHA-585 and no-loss bottle, Part No. BHA-5239, utilizing the right-hand upper shock absorber support plate bolts.
7. Remove and discard the thermostat housing and install modified housing, Part No. CHA-595.

8. Connect the vacuum and water hoses as shown in overall illustration.

NOTE:- Vacuum hose will have to be cut to length.
