WINDSHIELD DRY GLAZING CONFIGURATION/ASSEMBLY PROCEDURE

MARINA

75-C-3

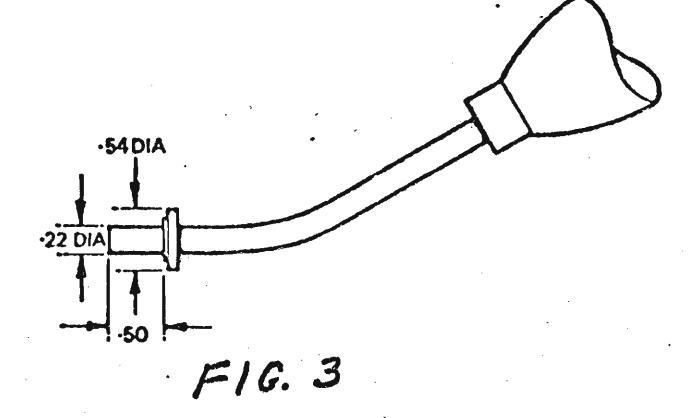
2. Plastic Drain Tube (Fig. 2)

If the outlet fitments at A or B located in the drain channels are leaking, these can be refitted without removal of the glass assembly. Access to the tube is provided in the dash top panel or from the trunk.

Using new parts, grommets CZK 8340 and inserts CZK 8341, assemble as shown. Push the plastic tube through the hole in the panel, push sleeve firmly onto tube, push assembly back into panel and press insert into sleeve. It is important for the head to be flush with the grommet and not distorted - for this operation it is essential to make up a simple tool (Fig. 3) as illustrated.
